# Snagging Inspection Report

## Sample report

## 12 Sample Close, Exometown

**14**

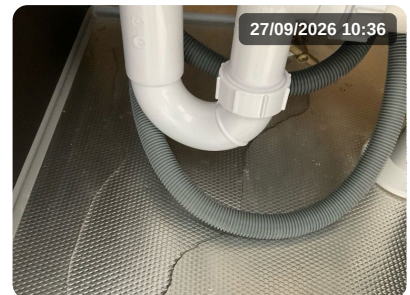
7

### Leaking waste pipe under the kitchen sink

The waste pipe beneath the kitchen sink is cracked and leaking, with water standing on the base of the sink unit.

NHBC Standards 2026, Clause 8.1.10 Internal soil and waste systems: soil and waste systems shall be "installed to ensure that effluent is removed without affecting health or creating unnecessary noise and smell", and should be "fixed neatly and securely to provide the correct falls".

Replace the damaged section of waste pipe, check all connections for leaks, and dry out the sink unit, replacing its base if it has been damaged by water.

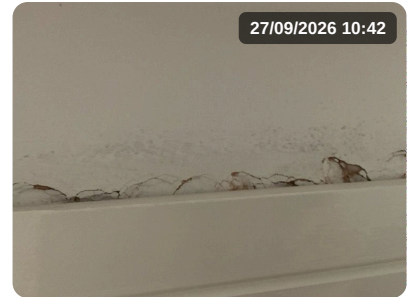
4

### Poor plaster and decorative finish

The plaster finish in the downstairs cupboard is poor, with cracked and flaking areas along the junction with the joinery and an uneven decorative finish.

NHBC Standards 2026, Clause 9.1.10 Paint finishes: painted surfaces should "be reasonably smooth and free from nail holes, cracks and splits", "have joints filled" and "be reasonably uniform in colour, texture and finish".

Reskim the affected areas to give a smooth, even surface, then redecorate to match the surrounding finish.

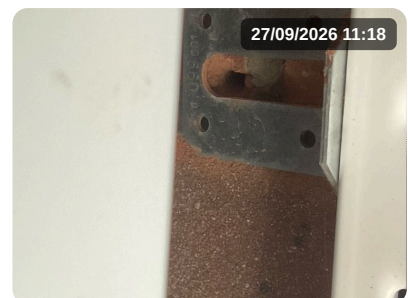
6

### Missing fixings to garage door bracket

Fixings are missing from the bracket securing the garage door frame, leaving the fixing holes in the bracket empty.

NHBC Standards 2026, Clause 10.1.8 Doors and windows (garages): frames "should be selected and fixed having taken into account the type and weight of the garage door", and "Proprietary doors and door gear should be installed in accordance with the manufacturer's recommendations."

Fit the missing fixings to the bracket in line with the garage door manufacturer's instructions, and check the door operates correctly.

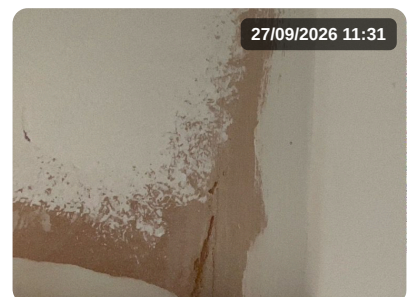
8

### Missing decorative finish to wall

The wall in the cylinder cupboard has not been decorated, leaving bare plaster and filler visible.

NHBC Standards 2026, Clause 9.5.10 Completed painting and decorating: "Painting and decorating should be complete", and "the background or undercoat should not be visible".

Prepare the wall and apply the decorative finish to match the surrounding walls.

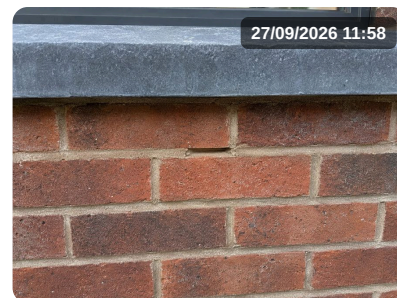
3

**Mortar discrepancy by the stone sill**

There is a mortar discrepancy to a joint in the brickwork by the stone sill on the rear elevation.

NHBC Standards 2026, Clause 9.1.2.1 Fair faced masonry: fair faced masonry should "be reasonably uniform in texture, finish and colour, including mortar". Clause 6.1.14.3 adds that the colour of mortar "should be consistent".

Make good the mortar to the affected joint so that it matches the surrounding joints in colour and finish.

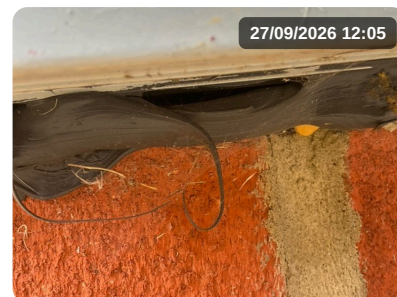
5

**Gaps in mastic under the patio door sill**

The mastic seal beneath the patio door sill is incomplete, with gaps and loose sealant along the joint between the sill and the brickwork.

NHBC Standards 2026, Clause 6.7.3.3 Accommodating movement: the perimeter gap around door and window frames "should be sealed with a suitable material which is able to resist water penetration and prevent air leakage whilst accommodating any differential movement requirements".

Remove the loose sealant and reseal the joint beneath the sill with a suitable exterior sealant, giving a continuous, neat finish.
