NHQB PRE-COMPLETION INSPECTION CHECKLIST (HOUSE)

# Pre-Completion Inspection Report

12 Sample Close  
Examptown  
AB1 2CD

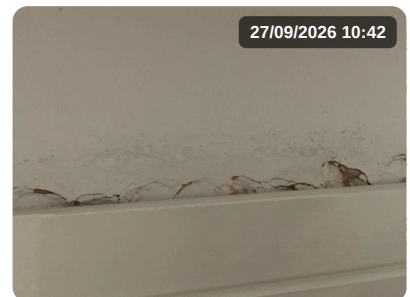
3

### Poor plaster and decorative finish

The plaster finish in the understairs cupboard is poor, with cracked and flaking areas along the junction with the joinery and an uneven decorative finish.

Reskim the affected areas to give a smooth, even surface, then redecorate to match the surrounding finish.

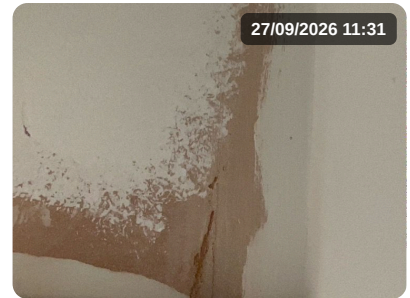
4

**Missing decorative finish to wall**

The wall in the cylinder cupboard has not been decorated, leaving bare plaster and filler visible.

Prepare the wall and apply the decorative finish to match the surrounding walls.

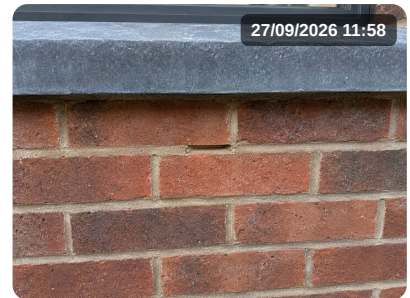
5

**Mortar discrepancy by the stone sill**

There is a mortar discrepancy to a joint in the brickwork by the stone sill on the rear elevation.

Make good the mortar to the affected joint so that it matches the surrounding joints in colour and finish.

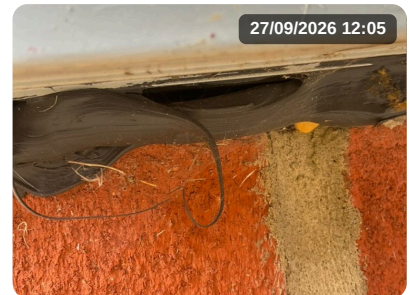
6

**Gaps in mastic under the patio door sill**

The mastic seal beneath the patio door sill is incomplete, with gaps and loose sealant along the joint between the sill and the brickwork.

Remove the loose sealant and reseal the joint beneath the sill with a suitable exterior sealant, giving a continuous, neat finish.

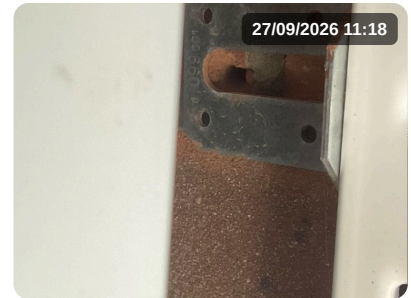
7

### Missing fixings to garage door bracket

Fixings are missing from the bracket securing the garage door frame, leaving the fixing holes in the bracket empty.

Fit the missing fixings to the bracket in line with the garage door manufacturer's instructions, and check the door operates correctly.

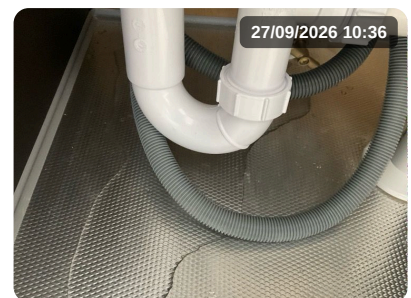
8

### Leaking waste pipe under the kitchen sink

The waste pipe beneath the kitchen sink is cracked and leaking, with water standing on the base of the sink unit.

Replace the damaged section of waste pipe, check all connections for leaks, and dry out the sink unit, replacing its base if it has been damaged by water.
